CASE STUDY

Pre-Commissioning Chemical Cleaning of Steam Package Boilers

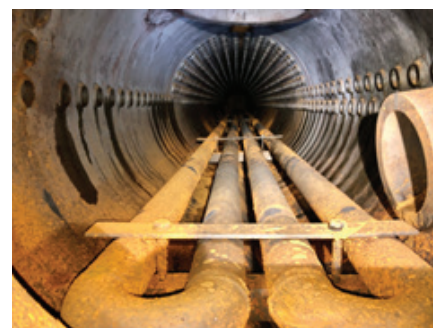
The client's steam package boiler had been installed several years before cleaning; their commissioning was delayed due to the COVID-19 pandemic. By this time, a reasonable amount of corrosion and debris had accumulated inside the boiler steam and mud drums. In discussion with the client's engineering team, it was decided to conduct a three-phase chemical cleaning of the boiler to ensure proper corrosion removal and passivation of the vessel.

Figure 1: Boiler mud drum before cleaning

To ensure that all components of the boiler (economizer, steam drum, mud drum, downcomers, and heating tubes) were cleaned, FourQuest's engineering team designed dummy doors on the mud and steam drums as well as downcomer flow

restrictor plates to ensure proper flow through all components. Regular backflow of demin water via the superheater was required, due to the sensitivity of the piping to the chemicals used for cleaning.

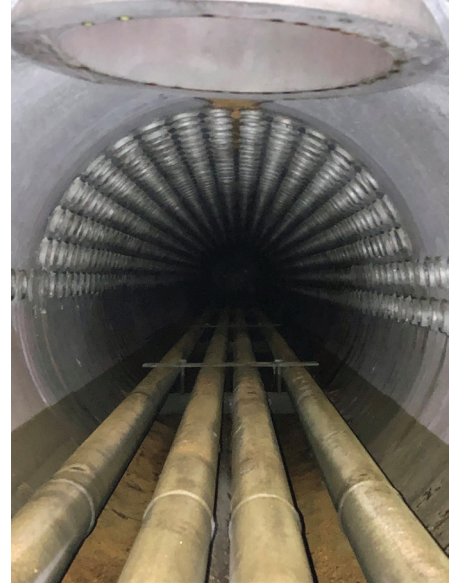
Figure 2: Boiler mud drum after cleaning

After chemical cleaning, the last trace of rust off the top of the steam drum was removed by confined space entry as per plan, as flooding of the steam drum was not allowed due to potential flow into the boiler superheater.
